## 20 Foot Above Grade Round Tapered Direct Burial Fiberglass Light Pole

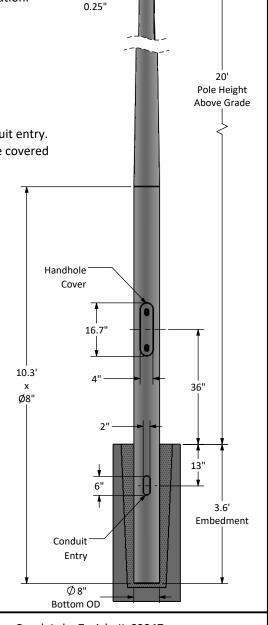
2-3/8" OD Tenon

Ø 3.0" \_\_\_\_\_
( Top OD)

Round

Pole Average Wall Thickness

Tapered

**Handhole:** An extra-large hand hole is provided for ease of access and installation. Handhole measures 16.7" X 4" and is located 36" above the ground line. A cover with 2 locking mechanisms and mounting screws are provided.

Embedment: Embedment length is 3.6 ft.

A  $2^{\prime\prime}$  X  $6^{\prime\prime}$  size slotted opening is provided  $13^{\prime\prime}$  below the ground line for conduit entry. All Sharp Edges around the Bottom of the shaft and around Conduit Entry are covered with Heavy Duty Rubber Trim.
